Little Paint Branch Watershed Study

**Montgomery County
Department of Environmental Protection
Watershed Management Division**

March 17, 1997

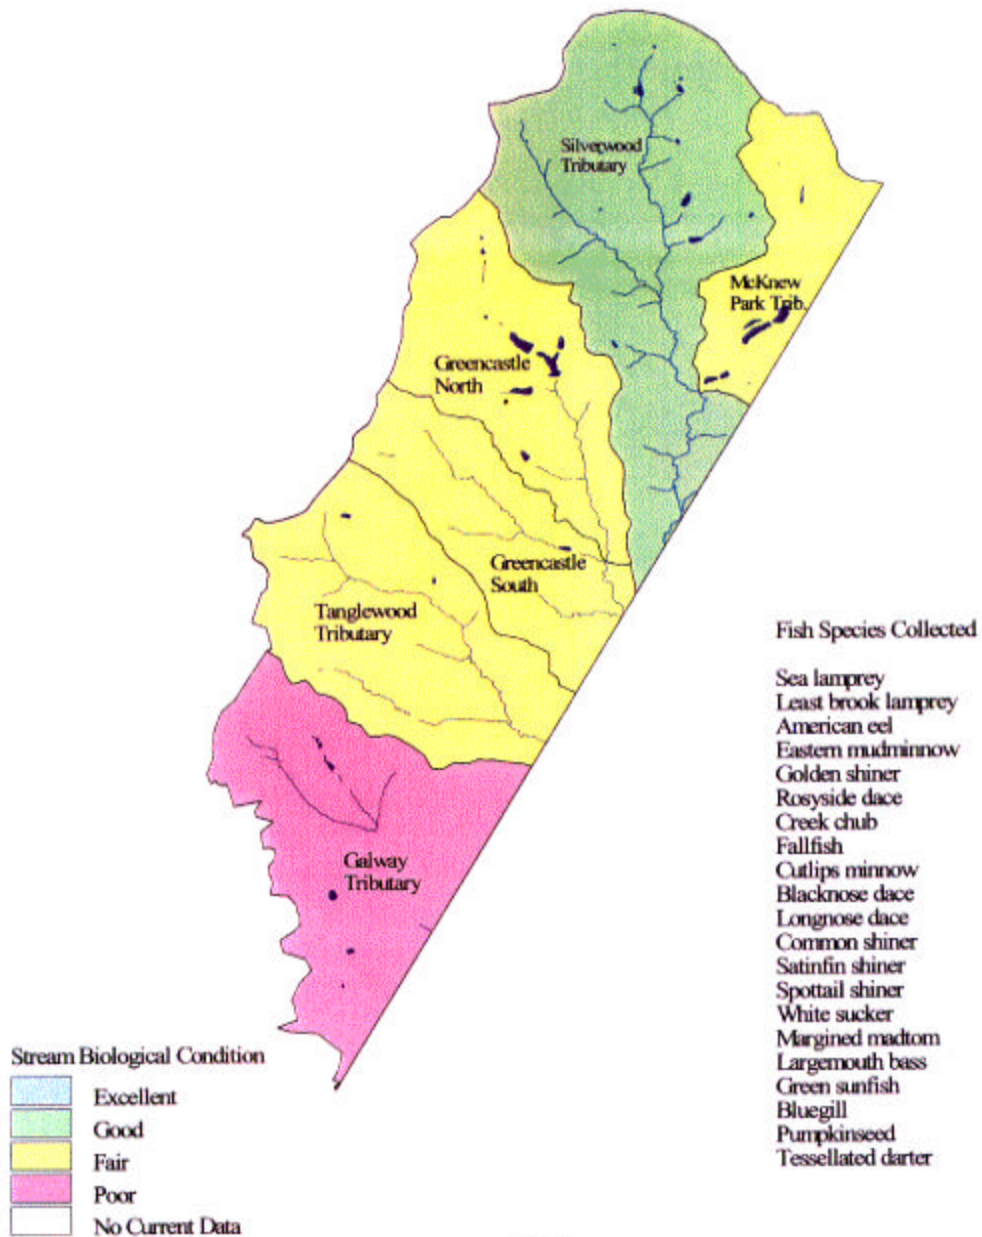
watershed during 1996 (Figure 2). Ten stream stations, distributed throughout the watershed, were monitored. Resource condition scores were determined for each of five subwatersheds; the Galway Tributary, Tanglewood, Greencastle South Tributary, Greencastle North Tributary, and the Silverwood Tributary (Figure 2). The Galway Tributary (Calverton area) received a resource condition rating of *poor*, the Tanglewood Tributary and the Greencastle South Tributary and the Greencastle North Tributary received a resource condition of *fair*, and the Upper Little Paint Branch (or Silverwood subwatershed above Greencastle Road) received a resource condition rating of *Good* (Figure 2).

The lower portion of the Galway Tributary is conveyed by a trapezoidal concrete channel and thus possesses little or no habitat value. Upstream of the trapezoidal channel, encroachment upon the channel by residential lots, a general lack of riparian vegetation, and high storm flows have limited habitat value within the channel. The habitat assessment for the Galway Tributary (station LPLP101) indicated a fair habitat assessment score. This was the lowest habitat rating within the Little Paint Branch watershed. The overall resource condition of the Galway subwatershed was rated as *poor* (Figure 2).

The Tanglewood, Greencastle South Tributary, and the Greencastle North Tributary developed latter than the Galway Tributary area and have more acreage controlled by SWM structures. There are areas without SWM controls, but to a lesser degree than the Galway Tributary. The Tanglewood Tributary (stations LPLP104 and station LPLP202), Greencastle South Tributary (station LPLP205), and Greencastle North Tributary (station LPLP204) received a resource condition rating of *fair* (Figure 2). Habitat at all stations was rated as good.

The Upper Little Paint Branch watershed received an overall resource condition rating of *good* (Figure 2). Five stream sampling stations were located in the Upper Little Paint Branch watershed (stations LPLP109, LPLP206, LPLP207, LPLP301, & LPLP302). The average benthic macroinvertebrate IBI rating for these sampling stations was *good*. The average fish IBI rating for

Figure 2. Stream Conditions Within the Montgomery County Portion of the Little Paint Branch Watershed

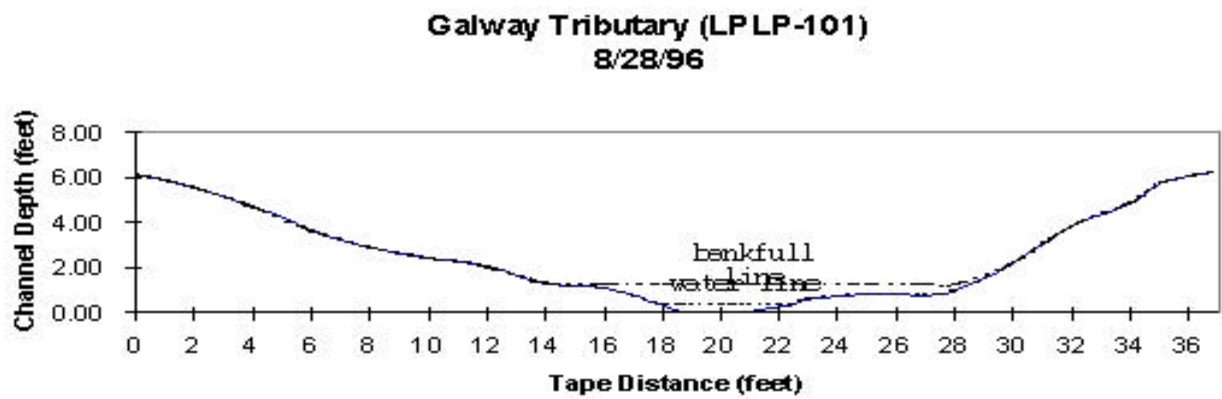
All rapid habitat assessment parameters were found to be fair or poor at the station on the Galway Tributary. The channel is entrenched with total bank heights averaging approximately six feet. Looking downstream, the right stream bank is nearly devoid of vegetation, approximately one-half of the left bank had vegetative coverage. The right stream bank possessed little or no riparian vegetation. This may be due, in part, to the fact that residential lawns were maintained up to the edge of the stream bank. Cross-sectional analysis indicates an entrenched stream that has lost access to its active floodplain (Figure 4). Pebble counts collected at the station indicate that the particle D50 for the riffle in this stream is small cobble (64 to 90 mm) (Figure 5). This is excellent benthic macroinvertebrate riffle habitat that is surprising to find here given the poor benthic macroinvertebrate community identified from this stream reach in 1996. The poor benthic macroinvertebrate community could be a result of the winter/spring floods in the subwatershed, or

Figure 4. Cross-section of LPLP101, within the Galway Tributary.

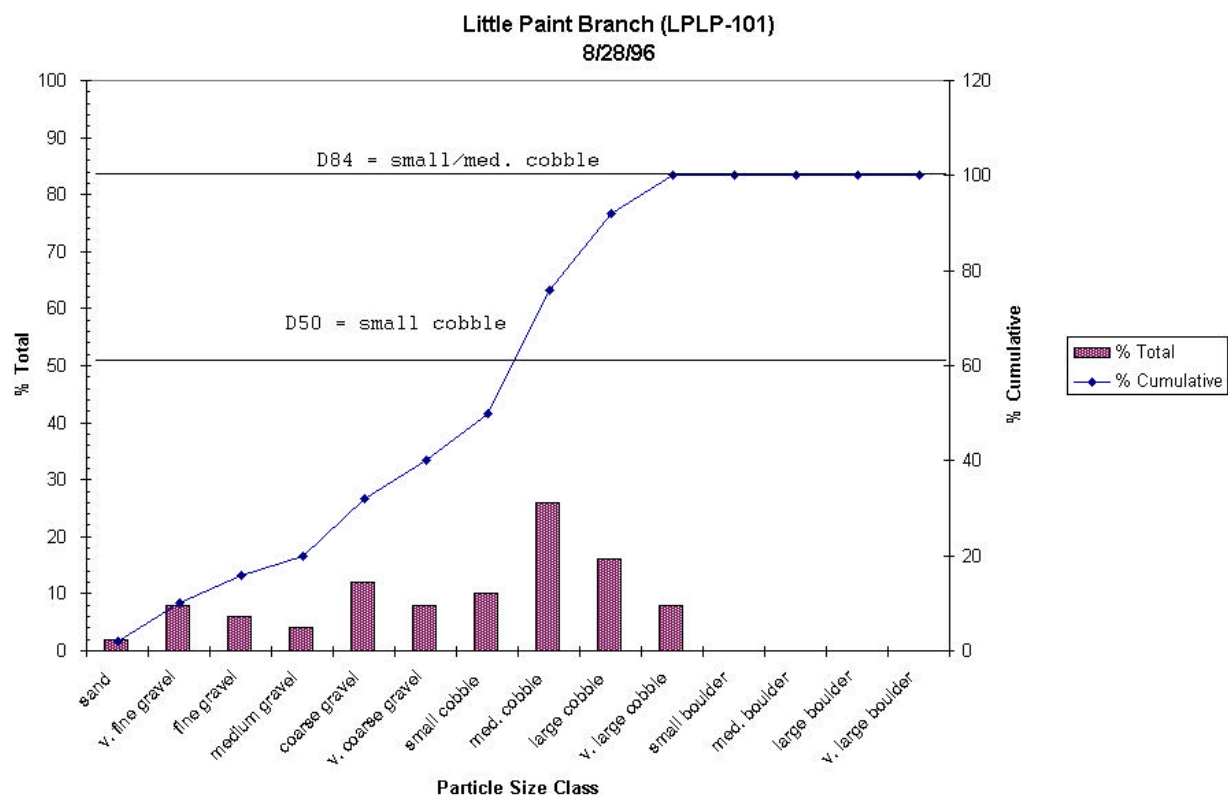
Figure 5. Pebble Count of riffle substrate within LPLP101, Galway Tributary. could be a result of pollutant discharges into the stream.

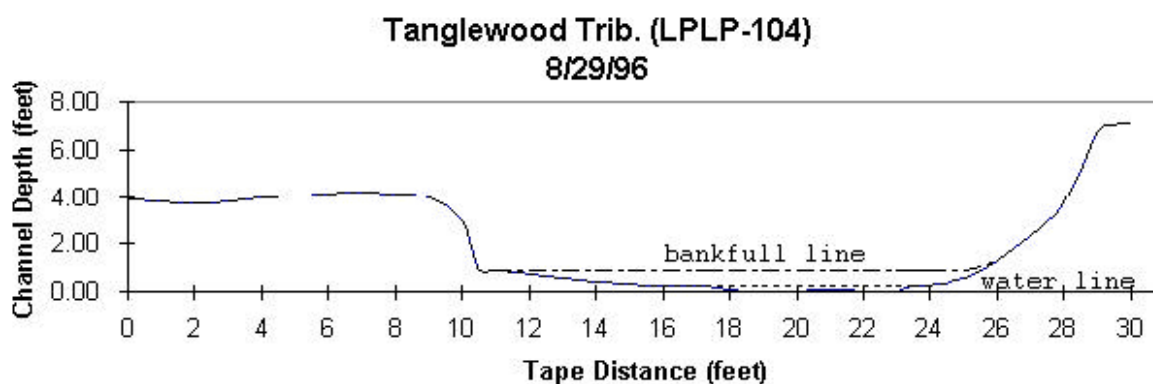
The cross-sectional information from the Tanglewood Tributary depicts an entrenched stream reach in this stream area (Figure 6). The channel at the Greencastle South Tributary is also entrenched, however, the stream may be forming a new active floodplain within the current channel width although at a lower elevation (Figure 7). The channel in the Greencastle North Tributary is also entrenched (Figure 8).

Figure 6. Cross-section of LPLP104, within the Tanglewood Tributary.

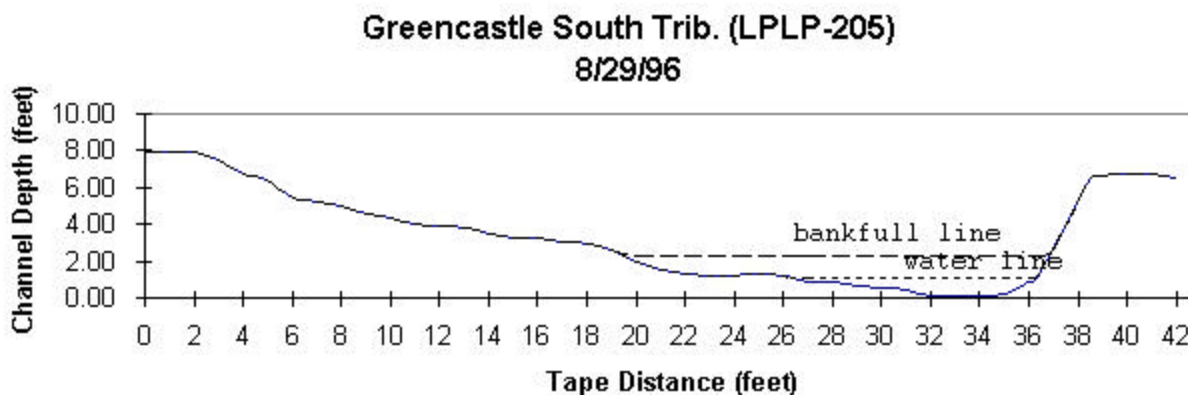
Figure 7. Cross-section of LPLP205, within the Greencastle South Tributary.

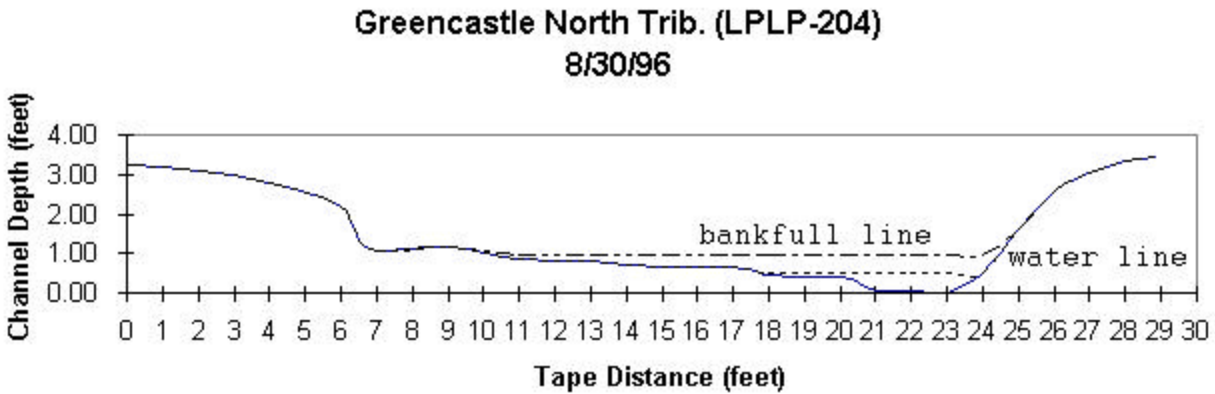
Figure 8. Cross-section of LPLP204, within the Greencastle North Tributary.

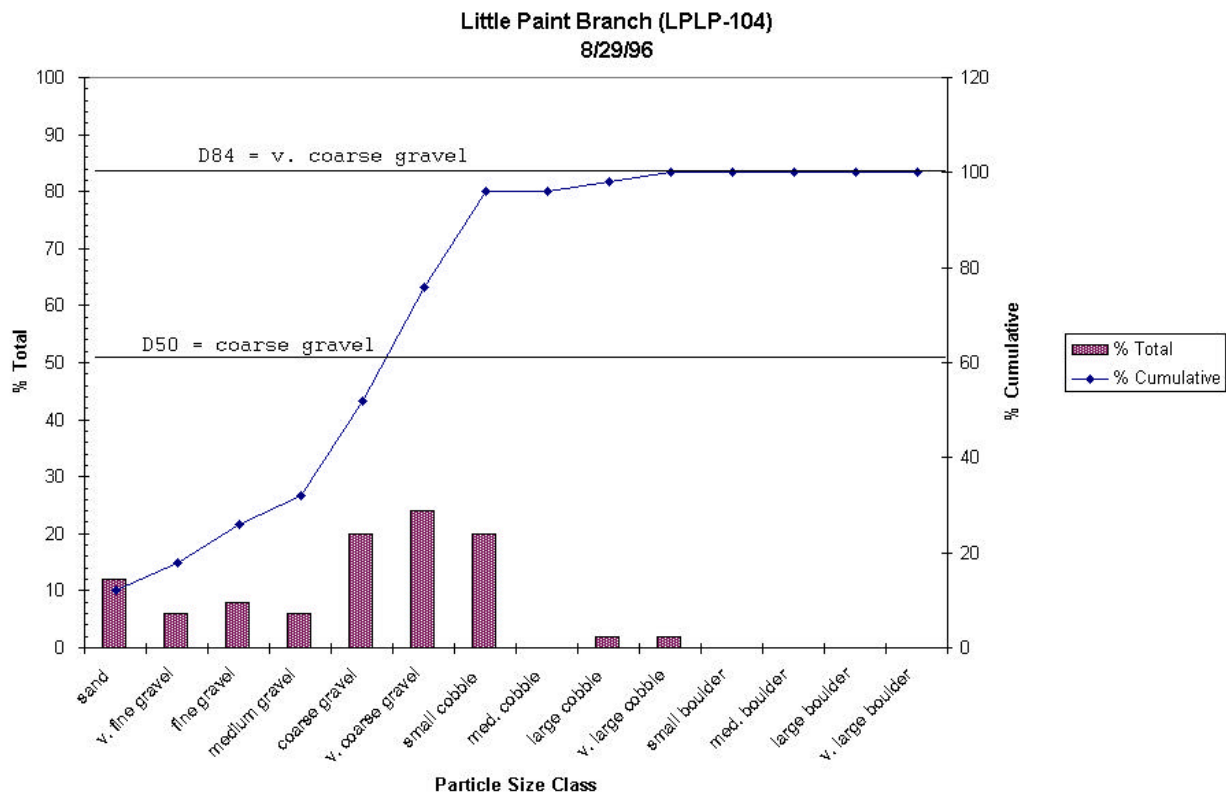
The dominant particle size in the Tanglewood Tributary monitoring station riffle was coarse gravel (16 to 32 mm) (Figure 9). The dominant particle size in the Greencastle South Tributary was also coarse gravel (16 to 32 mm) (Figure 10). The dominant particle size in the Greencastle North Tributary was slightly larger (coarse to very coarse gravel, about 32 mm) (Figure 11).

Figure 9. Composition of the riffle substrate (LPLP104) in the Tanglewood Tributary.

The small sized rocks in these riffles may be limiting the benthic macroinvertebrate community. The impairments seen in these three tributaries are most likely related to the physical effects of uncontrolled runoff.

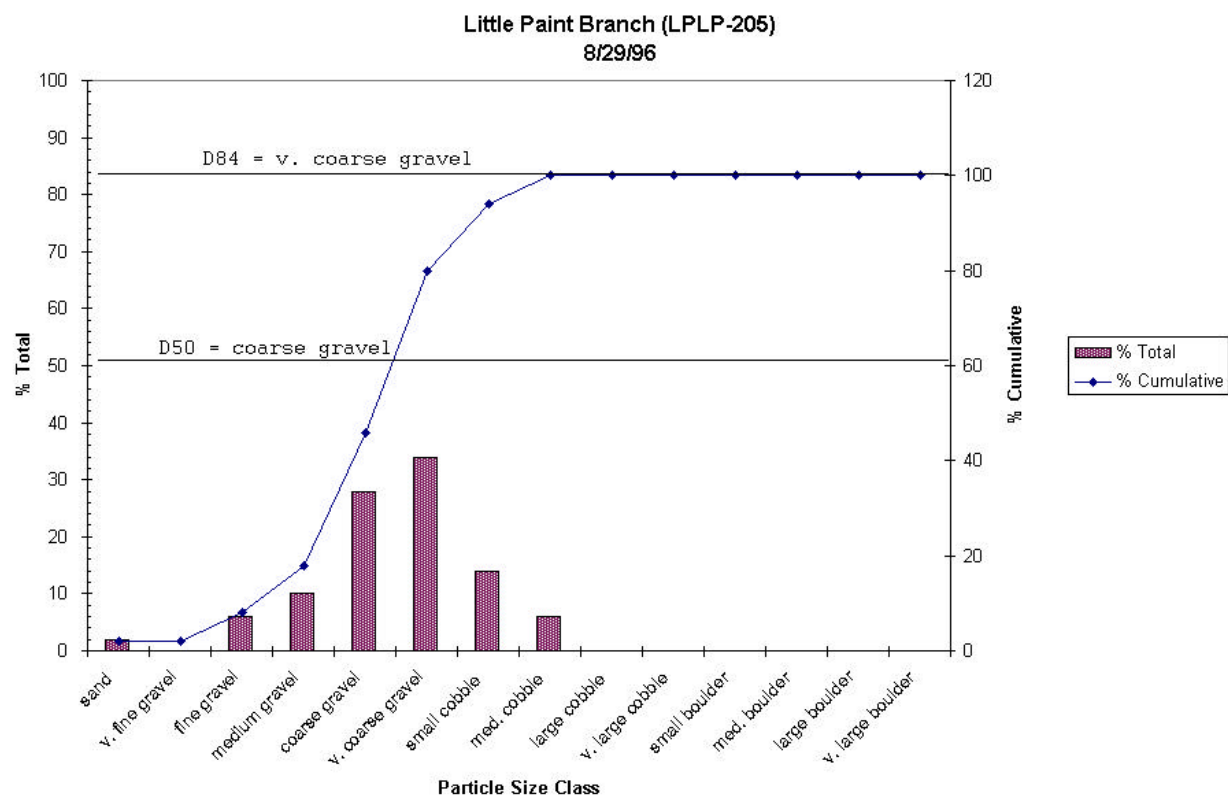
Figure 10. Composition of the riffle substrate (LPLP205) in the Greencastle South Tributary.

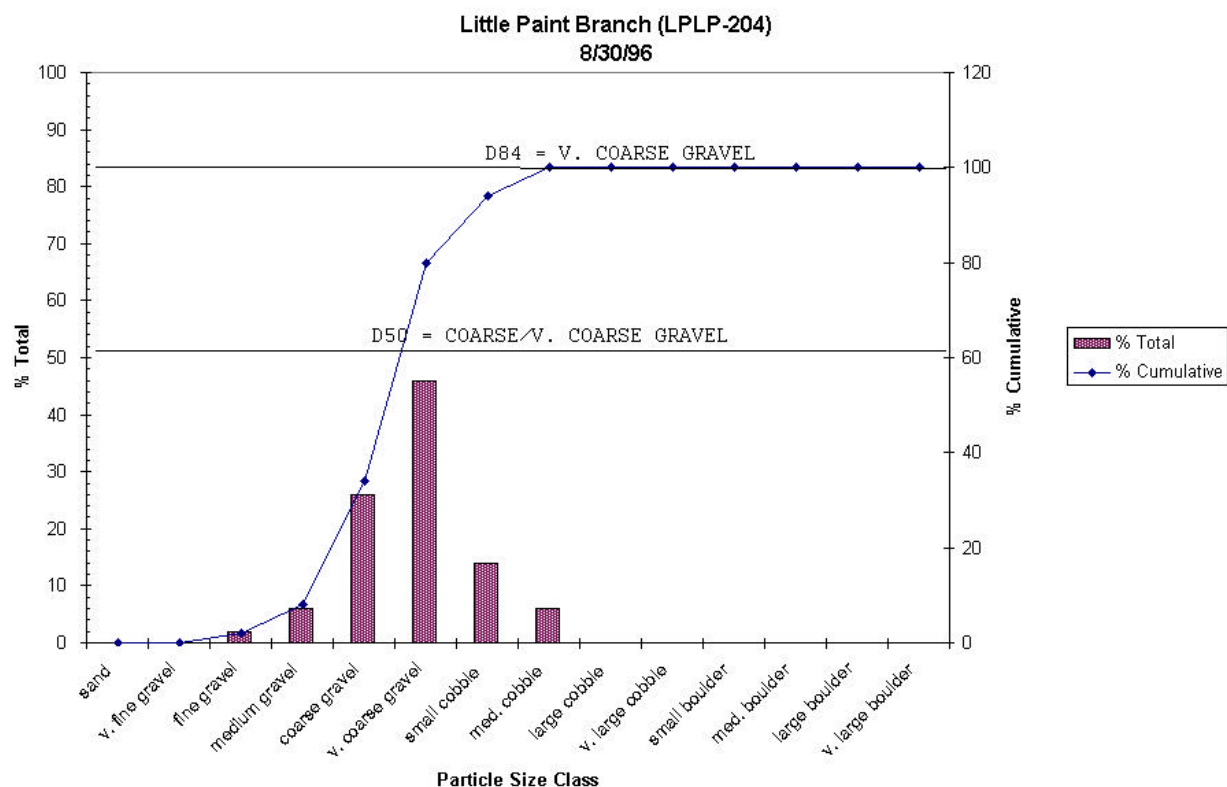
Figure 11. Composition of the riffle substrate (LPLP204) in the Greencastle North Tributary.

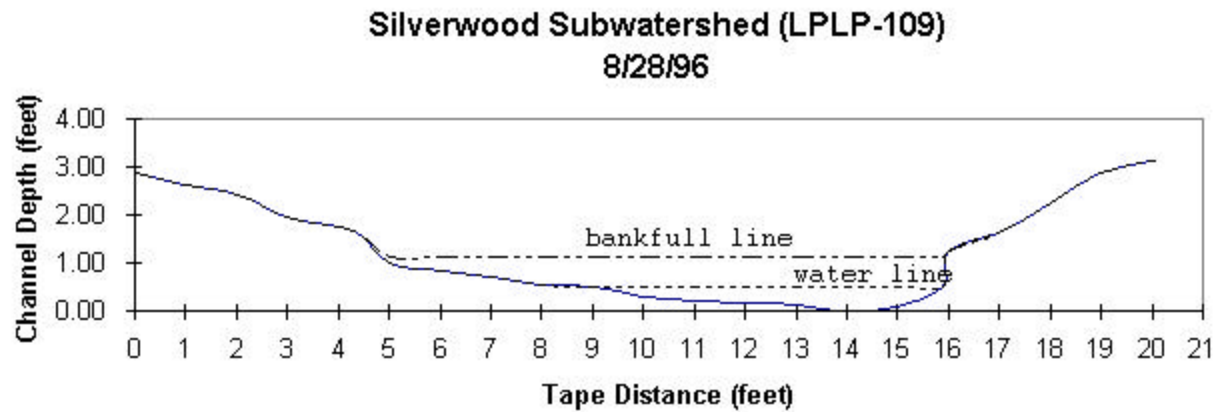
Figure 12. Cross-section within LPLP109, Silverwood Tributary.

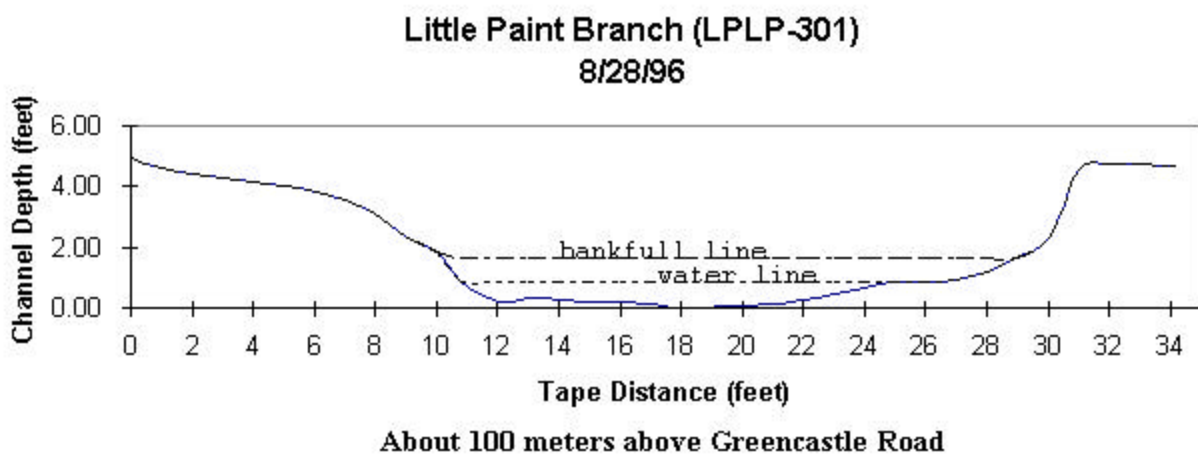
Figure 13. Cross-section within LPLP301, Little Paint Branch main stem above Greencastle Road.

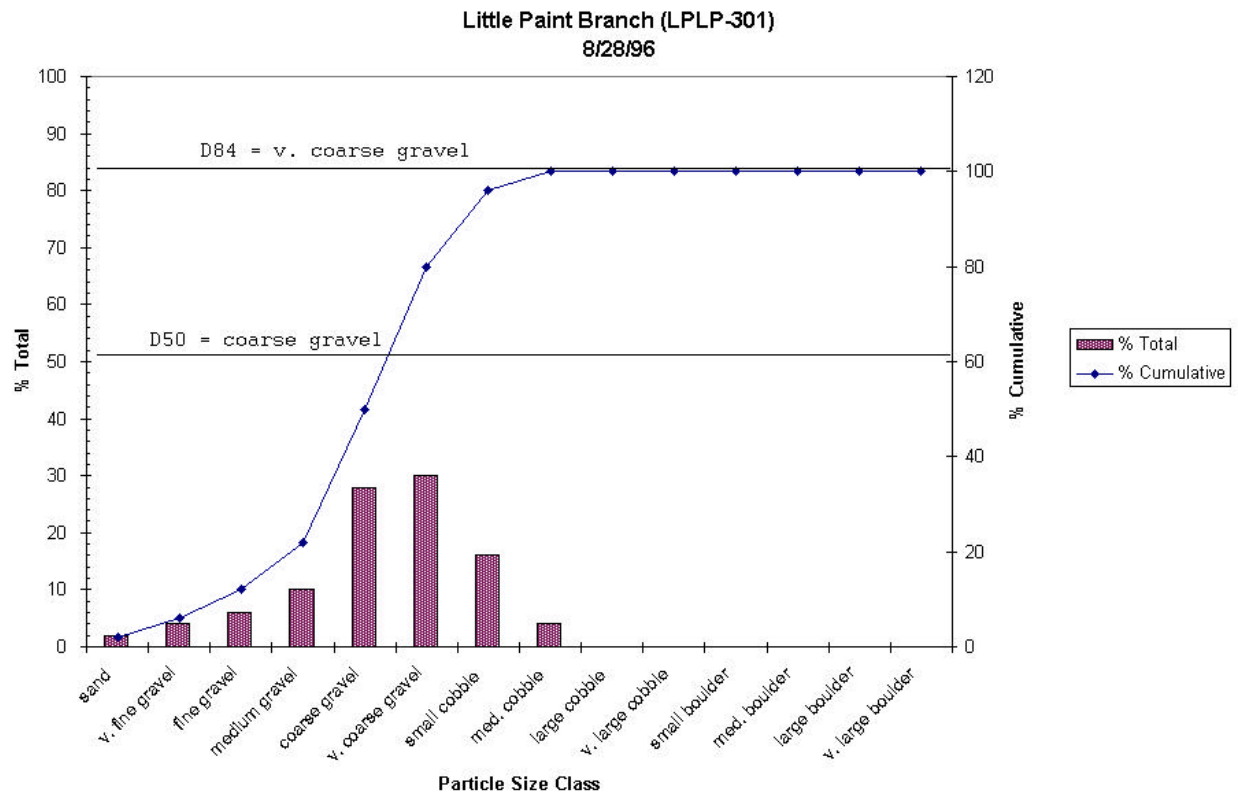
Overall, the habitat assessments conducted along the Silverwood Tributary indicated better aquatic habitat than anywhere else in the watershed. This helps to support the resource condition rating of good. The only less than desirable habitat parameter appears to be increasing sediment deposition in the lowest portion of the Silverwood tributaries watershed. Cross-sectional analysis shows that the channel within the Silverwood Tributary still has access to its active floodplain (Figure 12). The main stem of Little Paint Branch within Fairland Recreational Park (LPLP301) shows moderate channel entrenchment (Figure 13). Dominant particle size in the riffles in this subwatershed was coarse (16 to 32 mm) and very coarse gravel (32 to 64 mm) respectively (Figure 14).

Figure 14. Composition of the riffle substrate (LPLP301) in the main stem of Little Paint Branch above Greencastle Road.

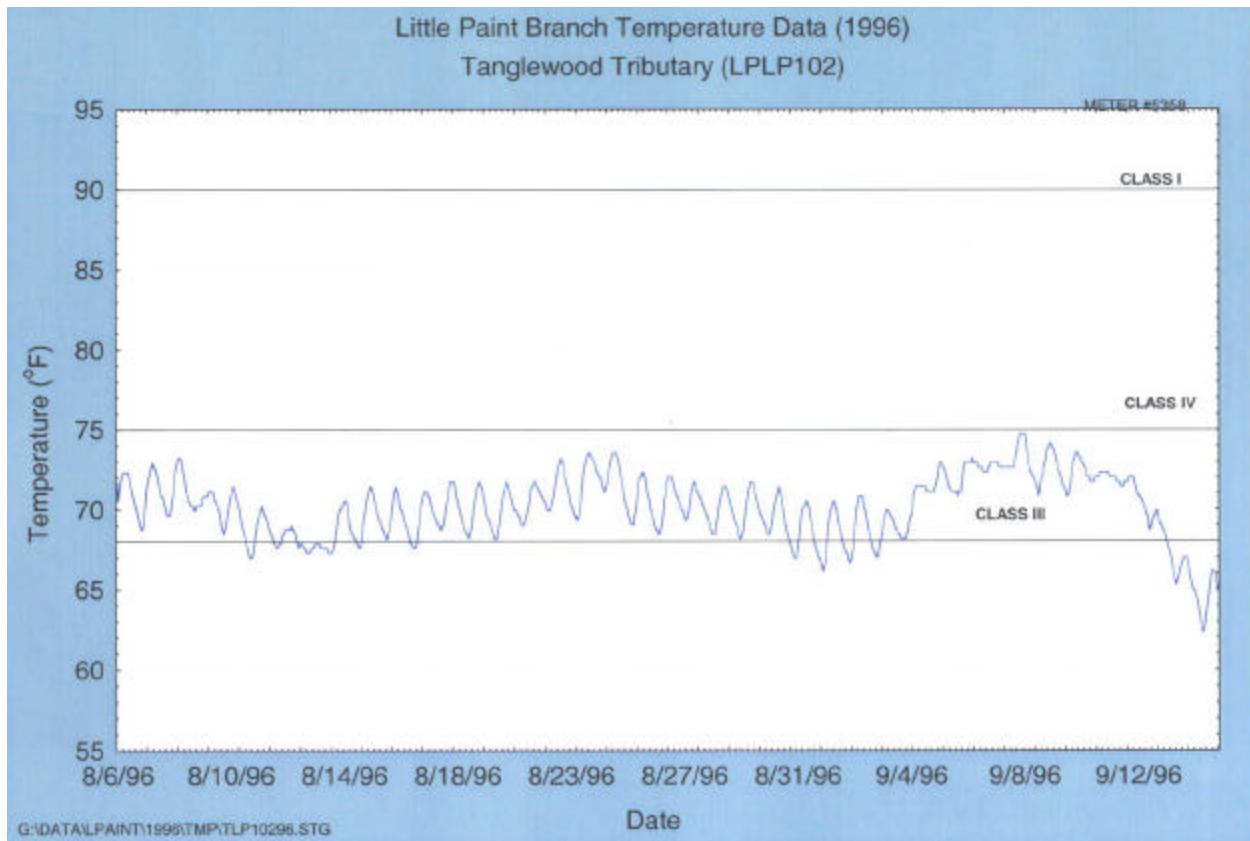
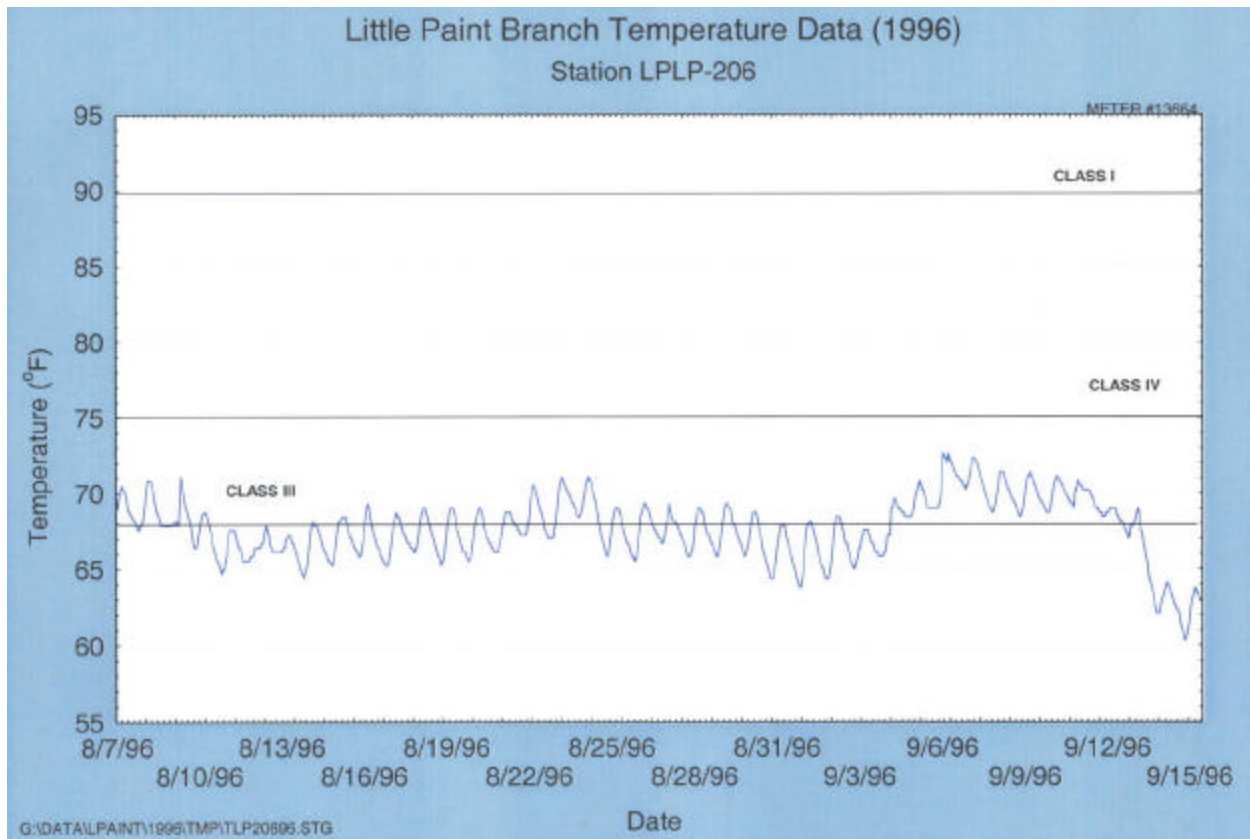
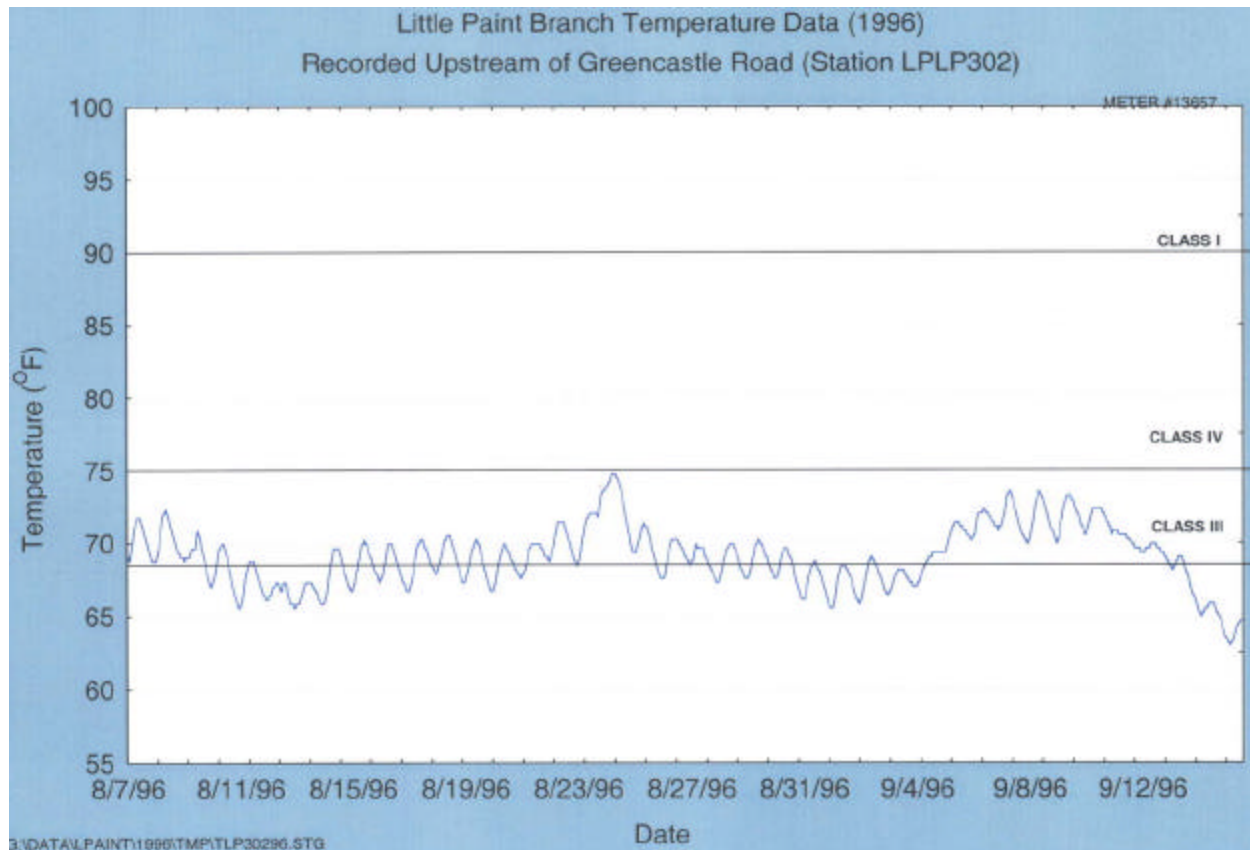
Three continually recording water temperature meters were placed within the Little Paint Branch watershed during August and September of 1996 (Figure 5). The August stream temperatures did not exceed 75° F. at any time at any of the stations. Overall, stream temperature does not appear to be a significant limiting factor in the Little Paint Branch watershed (Figures 15- 17).

Figure 15. Water temperatures in the Tanglewood Tributary, August 6, 1996 to September 12, 1996.

Figure 16. Water temperatures in Little Paint Branch main stem above the Silverwood Tributary, August 7, 1996 to September 12, 1996.

Figure 17. Water temperatures in Little Paint Branch main stem above Greencastle Road, August 7, 1996 to September 12, 1996.
